Production and Interpretation of Aerial Photographs and Maps Covering the Hudson Refinery Superfund Site in Cushing, OK

**In the matter of
United States of America v. Land O' Lakes, Inc. et al.**

**Case No. 5:16-CV-00170-PRW
U.S. District Court, Western District of Oklahoma**

**Prepared by Randall Grip, GISP
Aero-Data Corporation LLC
8280 YMCA Plaza Blvd.
Building 11
Baton Rouge, LA 70810**

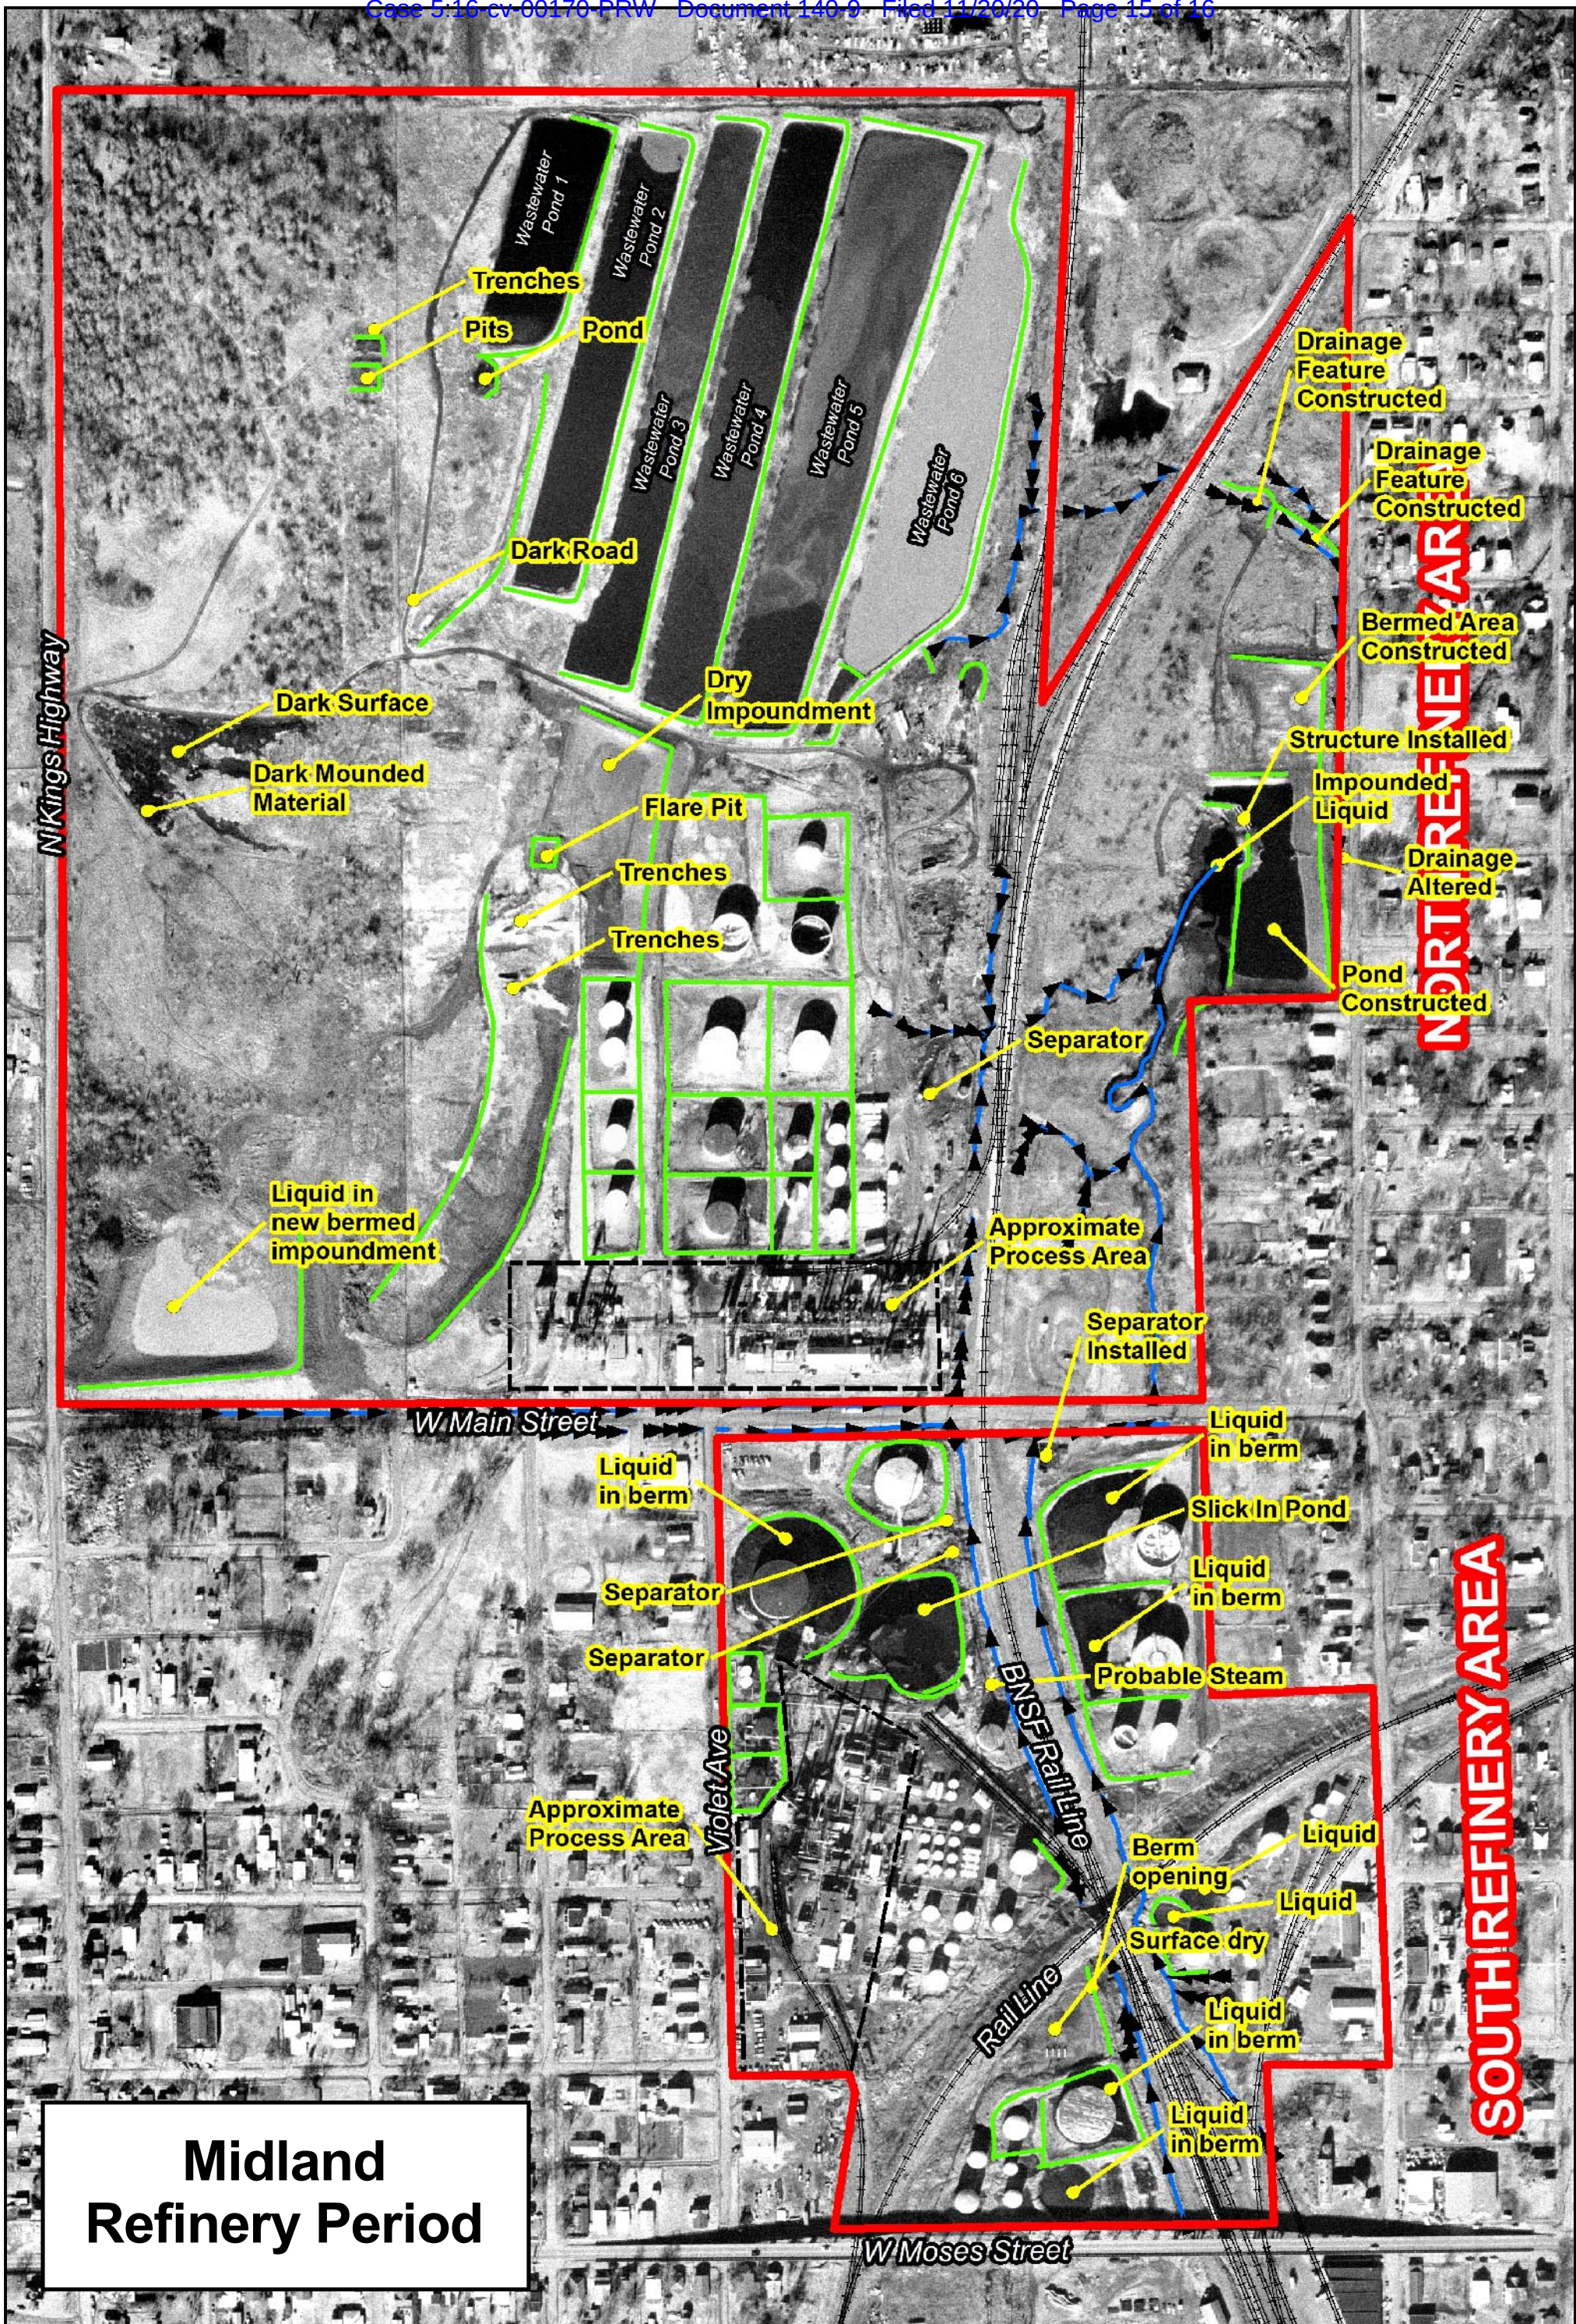
12/28/1972
Photo Source: ODOT

Additional trenches are visible southwest of Wastewater Pond 1. A large area with a dark surface and dark mounded material are visible on the western portion of the area which appear to be indication of land farming activities. A bermed area with liquid is visible for the first time in the southwestern portion and labeled in future dates as "Firewater Pond 11." Road oiling is visible west and southwest of the series of Wastewater Ponds.

To the east of the rail line, drainage features and bermed areas have been constructed north of the previously visible flow control structure. A structure is visible for the first time with impounded

liquid to the west and a pond first visible to the east. A drain is first visible east of the structure to carry offsite.

A slick is visible in the pond. A separator is visible near the drainage features on the northern portion of the area east of the rail line.
